REPORT NO. FAA-RD-78-155

**A STUDY OF THE EFFECTS OF AIRCRAFT DYNAMIC
CHARACTERISTICS ON STRUCTURAL
LOADS CRITERIA**

Robert L. Stapleford
Richard J. DiMarco

November 1978

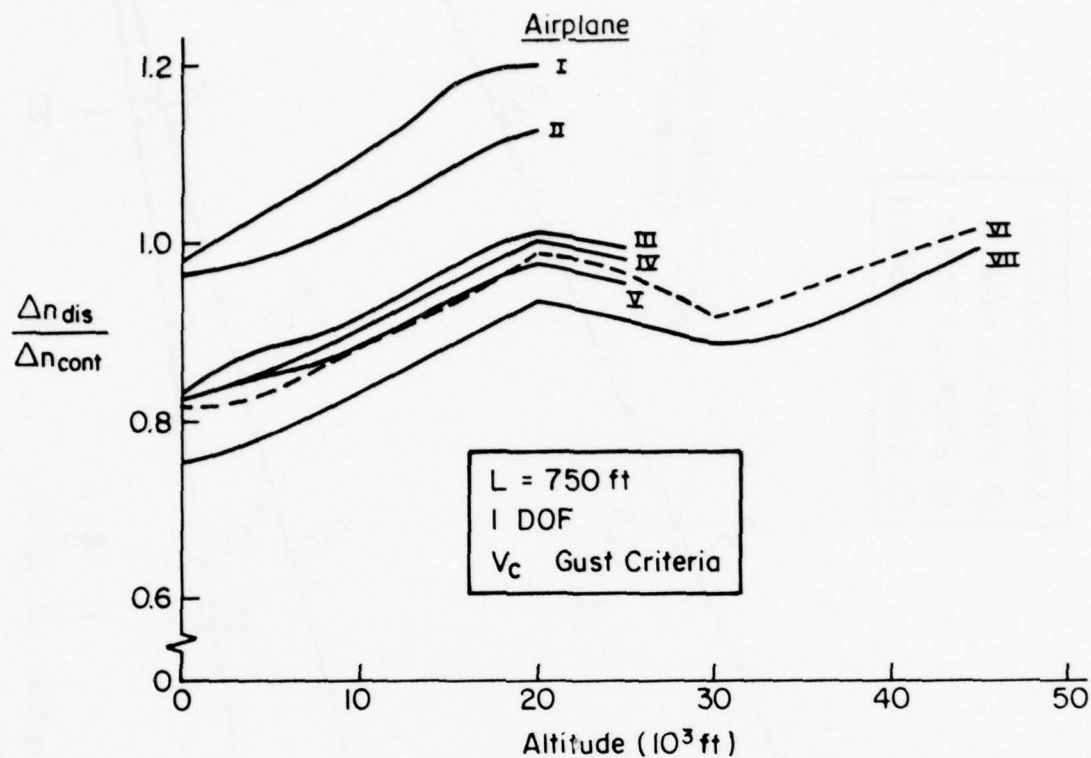
Figure V-5. Sample Effects of Altitude

*The breaks in the curves at 20,000 and 30,000 ft are due to variations of U_{de} and U_G which start at those altitudes.

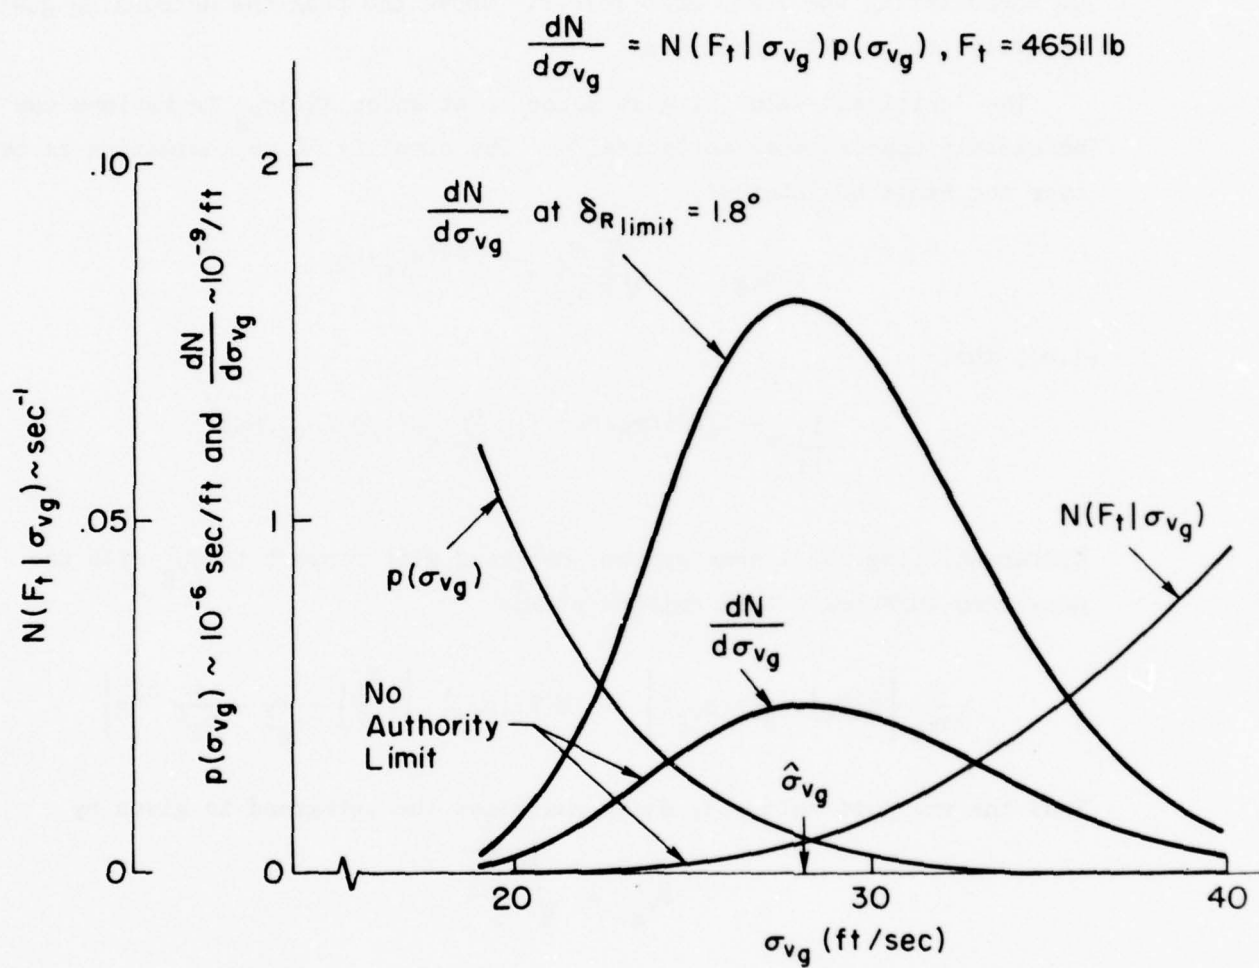
Figure V-9. Variations of Exceedance Rate Integrand with Gust Velocity

Before presenting the results of that integration, it is instructive to try to predict the outcome. To do this consider the case of no yaw damper limit. Overall exceedance rates for this linear system can be computed using Eq. V-5, just as for the nonlinear case; of course, the computation is simpler since \bar{A} and N_0 are constant. Figure V-9 shows the variation of the integrand, $dN/d\sigma_{vg}$, and its component factors, $N(F_t|\sigma_{vg})$ and
